Bulletin Number: YATB2015-001-A_SA221/324/424_PTO SW Circuit_Mandatory requirement

SA221/324/424 IMPROVEMENT OF PTO SWITCH CIRCUIT

AFFECTED MODEL(S): SA221, 324, 424

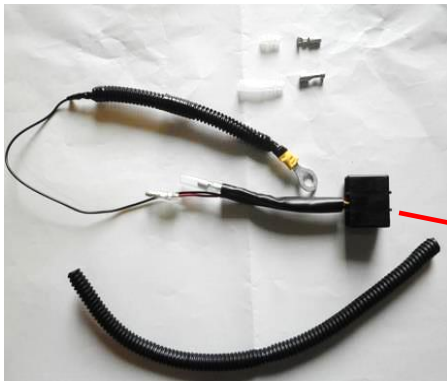
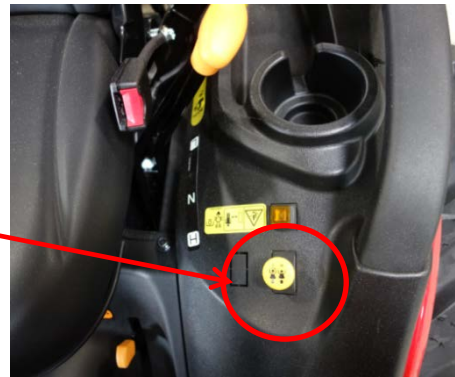
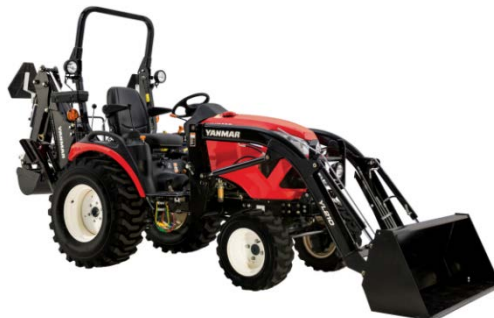
It has been reported that in some cases when significant amount of water is introduced to the PTO switch, the PTO switch may engage due to a short circuit when the PTO switch is in the OFF position.

1. Please kindly contact your original purchasing dealership or nearby Yanmar dealership to perform this rework. Yanmar America will be providing rework parts to each affected Yanmar dealership as soon as possible but no later than July 10th, 2015.
2. The dealership will perform an installation update to the PTO harness on your unit.
